# Archaeological Excavation of a possible monastic grange building at Water's Clough, Castleshaw, Saddleworth

May 2018

Report written by Norman Redhead  
for the Friends of Castleshaw Roman Forts

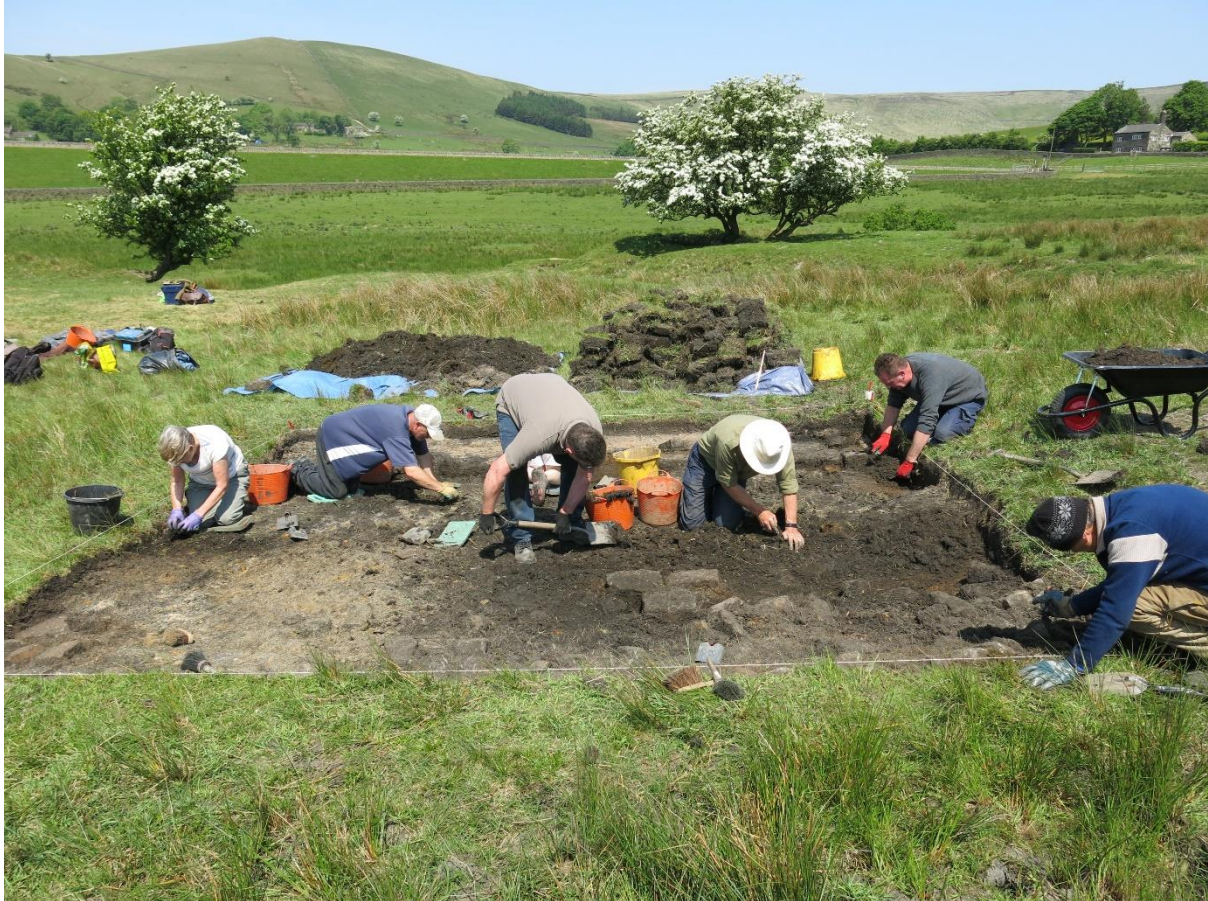
Friends of Castleshaw Roman Forts volunteers excavating Trench 1

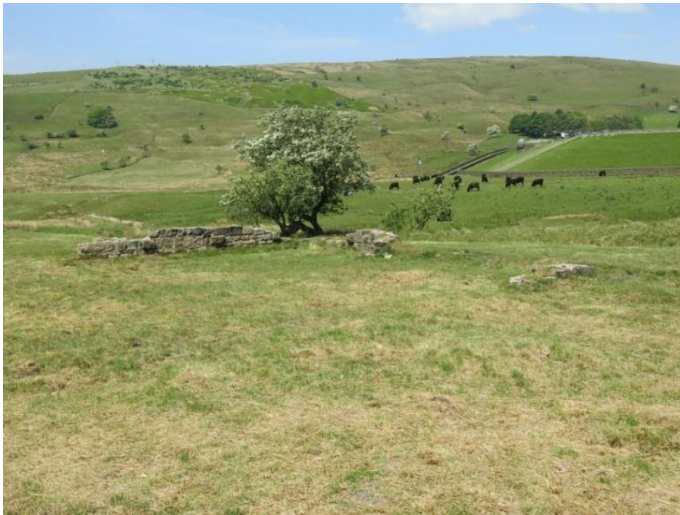
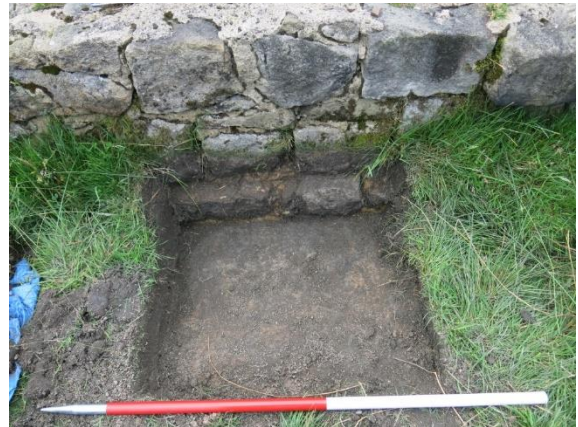
The ruin beside Waters Clough (left) and test pit against inside wall showing offset in foundation (right)

Investigations by the Friends commenced in 2016 with a resistivity survey and a couple of one metre square test pits excavated either side of the northern wall of the ruin to examine the depth of the wall foundation and evidence for a floor surface. The external test pit revealed two courses of stone representing a wall depth at this point of 40cm. A deposit of mid-grey silty clay loam with frequent pieces of mid orange-yellow mortar was encountered level with the base of the first course of stonework, at a depth of 30 cm beneath the turf line. This deposit was c 15 cm deep against the wall and tapered away from it, being the construction phase material. It was evident that the foundation trench was cut very neatly and was very close to the foundation stonework. The wall itself was 50 cm wide and well built in coursed gritstone with a thin rubble core and occasional larger stones spanning the full width. The interior test pit was located next to an internal return wall. This found stiff, natural clay (white or light yellow in colour) at a shallow depth of around 10 cm, with no evidence for a floor. The internal wall butted up against the external but was of similar construction. The natural clay is an excellent material for building on. The foundations were robust and well-constructed, which is consistent with the high quality of walling seen elsewhere in the structure. A further, small test pit was excavated against the inside of the western wall and found to have an offset at foundation level. This could have been used to support a timber floor.

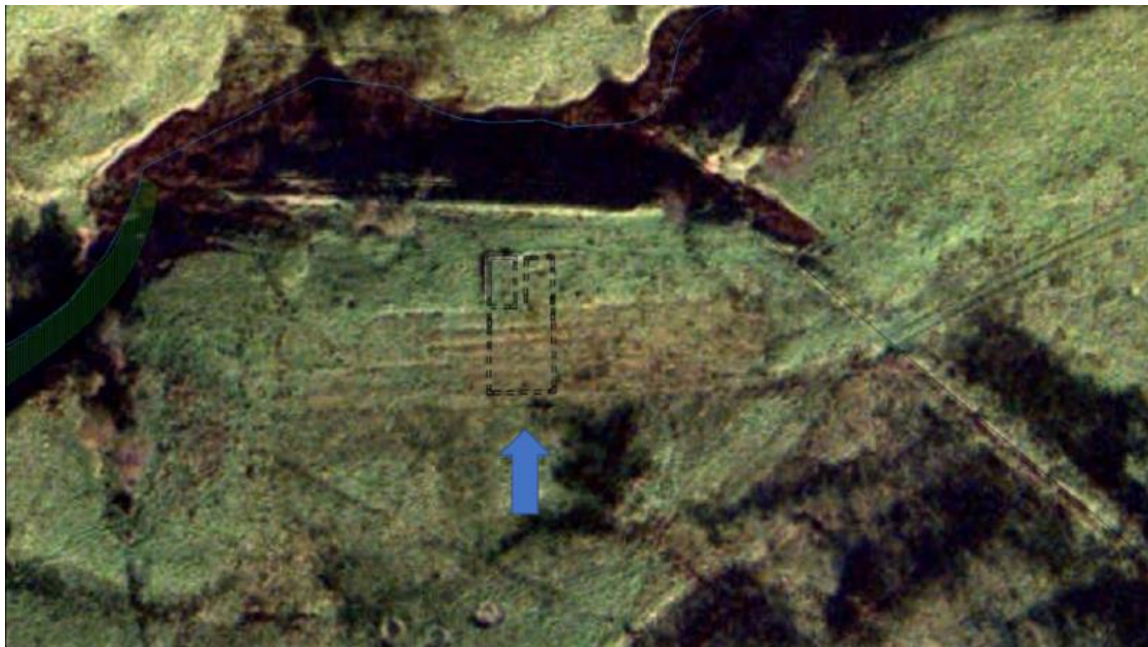
The aerial photograph above, dating to the late 1990s, shows the line of walls revealed during the 2016 investigations. These depict a structure measuring 20 by 10 metres aligned on a north to south axis. On either side of the structure can be seen a rectangular area with lines representing potential walls and gullies of unknown function.

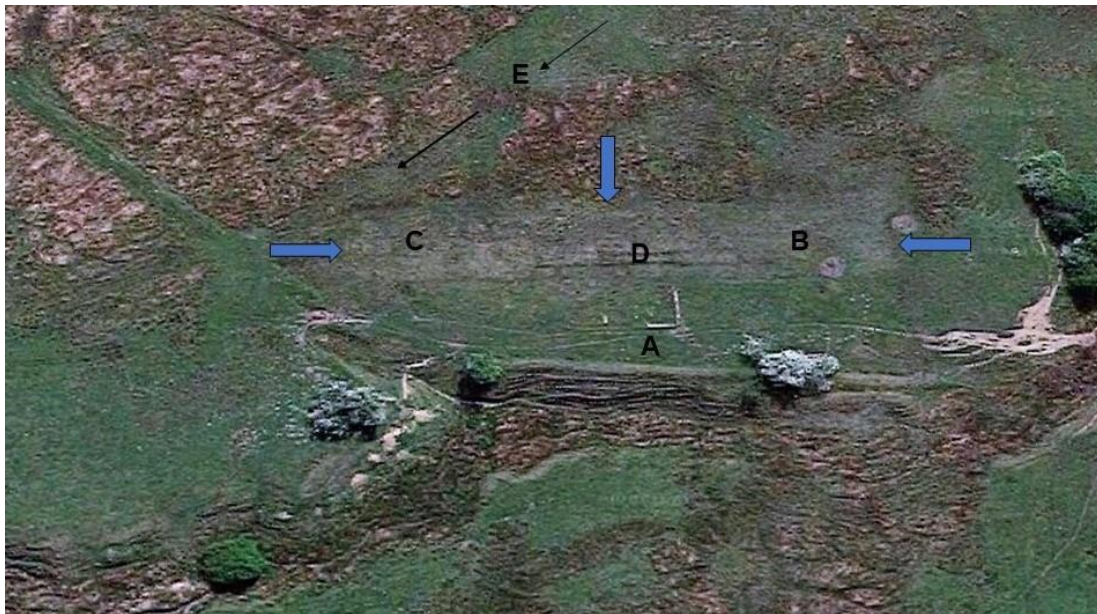
The Google Earth picture below shows the same site but looking from just north of the ruin. The key indicates the main features: A = remains of ruined walls beside the bank of Waters Clough with a pronounced earth bank bounding the edge of the slope down to the clough, B = rectangular platform of possible western range, C = rectangular platform of possible eastern range, D = central range incorporating the ruined walls and showing parallel lines, with the southern edge of the central range defined by a vegetation change, E = the line of the Roman road which appears to be partly cut into by the eastern range building platform (C).

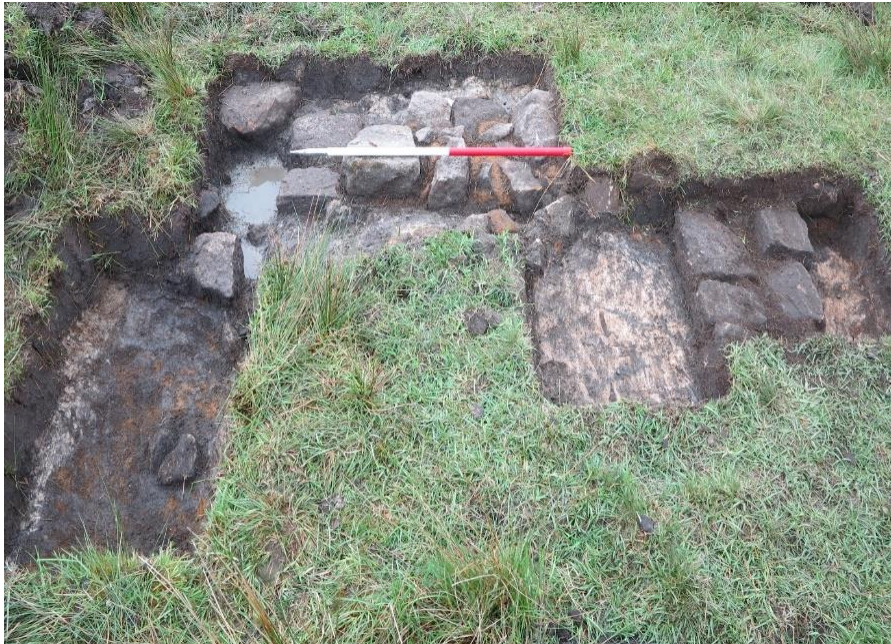
South-west corner looking north, showing wall trench to left and surviving wall foundation to right, which indicate the location of a projecting chamber

The south-west corner contained the stone footings of the south wall but the western return wall had been mostly removed and survived only as a robbed-out trench with a few disturbed stones in the fill. As with the north-west corner, there was the suggestion of a buttress or wall projecting southwards from the corner of the building in the form of a robbed-out foundation trench. This was exposed for 2 metres. Bearing in mind the projecting room found in Trench 1 at the south-east corner of the eastern range (described below), the team opened up a test trench against the external face of the south wall and located a corresponding wall at 1.7 metres from the corner. This wall was excavated for about one metre to confirm its alignment. It was built of exactly the same materials as the rest of the building's walls and survived one course high above the natural ground surface. There was not enough time to complete excavations here, but it can be confidently predicted that these two projecting walls were for a similar room to that found in Trench 1 ie. a small chamber of 2.4 x 1.7 metres internal measurement.

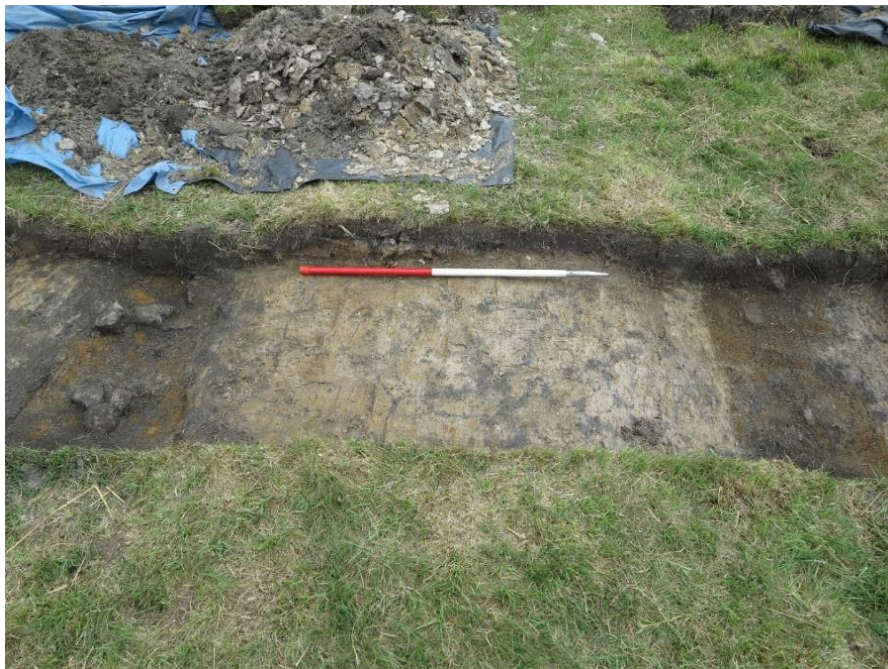
Trench 4: parallel foundation trenches within the eastern part of the western range

Attention now turned to the linear depressions apparent in the aerial photographs within the central range and eastern part of the western range. A 4 x 1 metre trench was excavated on a south to north alignment across what initially was thought to be drains or wheel ruts, but they were found to be more wall foundations where the stonework had been removed as part of the demolition/recycling process. The wall lines were evident as linear cuts into the natural clay, filled with orange mortar and occasional stones. They were 2.15 metres apart and 0.5 metres wide. The natural light-yellow clay formed a slightly convex profile between the foundation trenches; this might reflect disturbance caused by cutting down to get at the foundation stones.

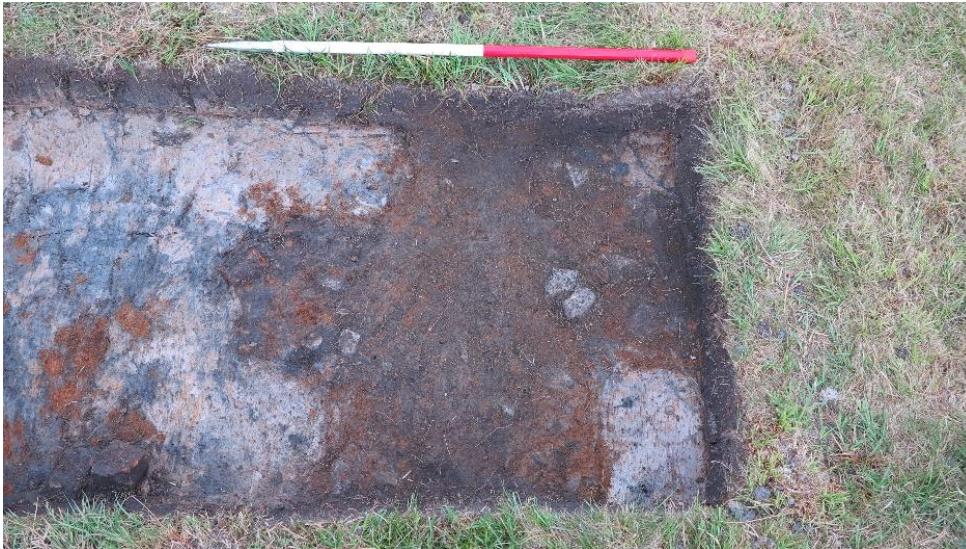
Trench 5

discovered, representing internal room divisions. As one of the foundation trenches was followed to the south it faded out due to extensive, deep robbing out of the wall foundation at this point as can be seen to the left of the photograph below. This may also be down to some of the internal wall division having shallower foundations than key, load bearing walls.

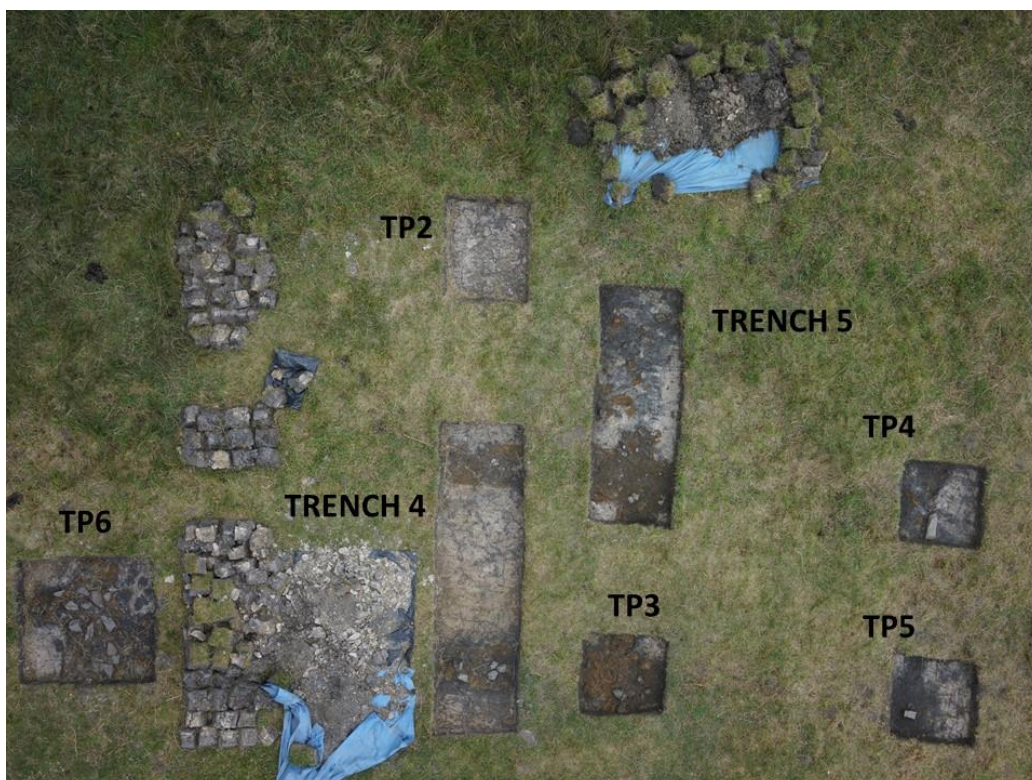
Location of trenches and test pits in western range (south is at the top). TP 6 is located over the central range's west wall.

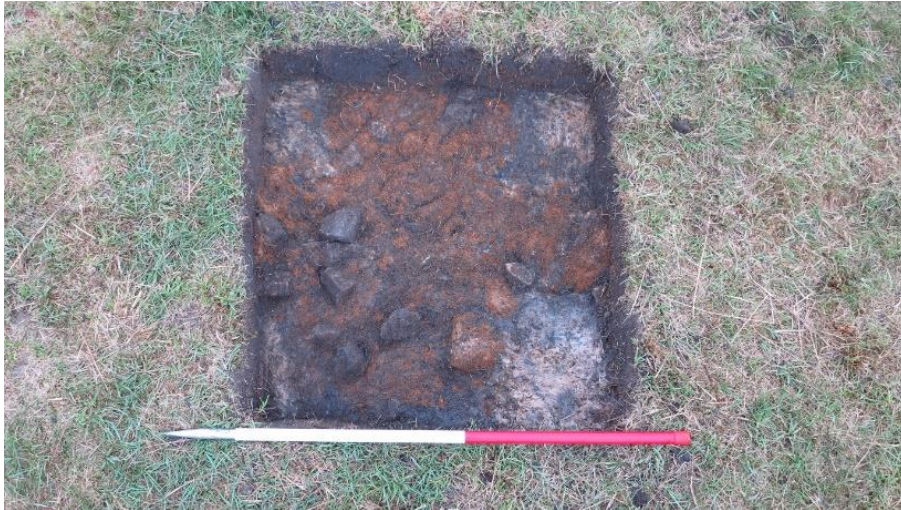
TP3 was positioned to confirm wall alignments internal rooms noted in Trench 5. As can be seen in the photograph below, the test pit revealed two south to north orientated wall foundations for internal room divisions, as well as the continuation of the east to west wall already observed in Trench 4. As seen in

adjacent trenches, the stonework was completely robbed out with only dark orange mortar and loose stones present in the foundation trench cuts.

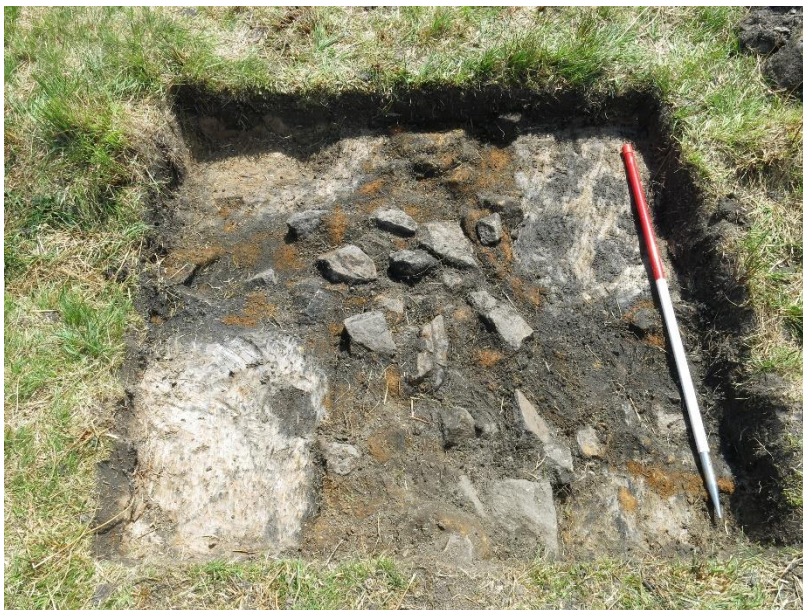
TP6 examined the junction of the northernmost internal wall (as seen in Trench 4) with the central range wall. The photograph below shows the central range wall running up through the middle of this image which looks south), with the western range internal wall joining from the right-hand side. This confirms the existence of an internal room. As seen elsewhere, the wall foundation stones have been totally grubbed out with only the orange mortar, discarded stones and grey silt remaining. Interestingly another wall can be seen on the left of the image, this being an internal wall within the central range and creating a staggered junction.

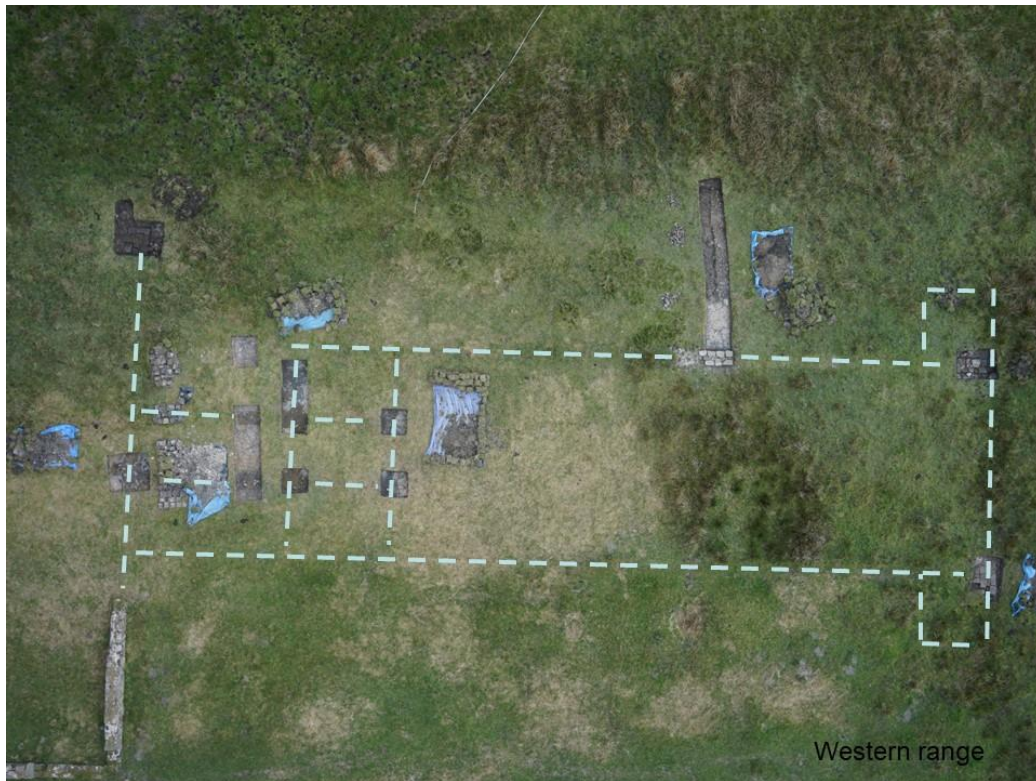
Drone vertical photo of the western range with dashed lines showing wall foundations confirmed or suggested by excavation. The projecting corner chambers can be seen on the right, with the internal rooms on the left at the east end by the central range.

In summary, these excavations in the western range found two wall lines running parallel with the north and south external walls and also walls at right angles creating small chambers or rooms. There appeared to be five of these: a set of three occupying the full width of the building, measuring 3.4 by 2.15 metres internally, and a further two adjacent to the central range which were the same width but longer at 5.1 metres. It was

anticipated that there would be a third room next to the central range, on the southern side of the building, but a test pit found no evidence for a wall foundation trench. This area needs further investigation to confirm the layout.

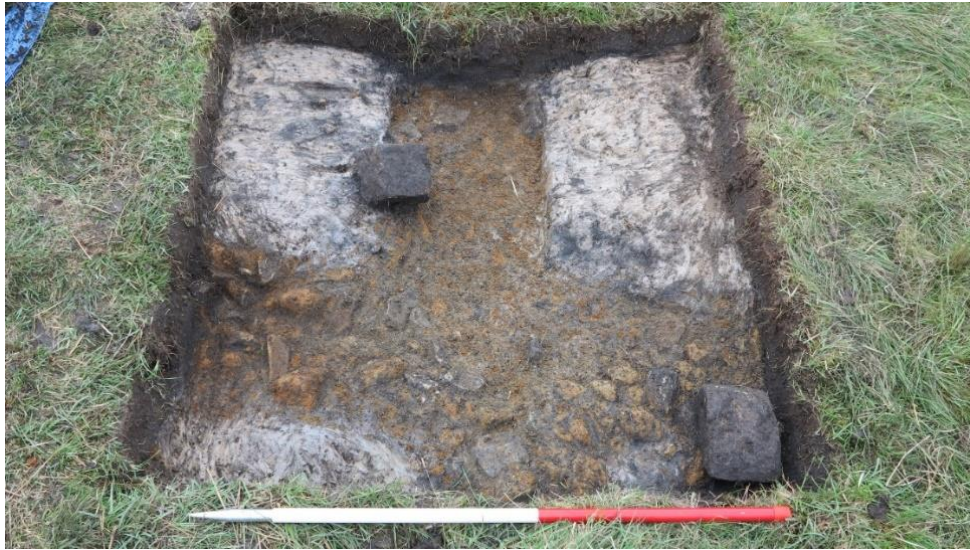
Test pit 1 pre-excitation, looking east.

TP1 was opposite TP6 and had the same staggered junction arrangement, with an outer wall line representing an internal room in the eastern range, and an internal wall foundation within the central range being the other side of the corridor indicated in TP1 and by linear depressions evident on aerial photos. The former walls were represented by just two stone blocks with the rest of the foundation trenches being filled with orange mortar and small stones. Sections were excavated through the foundation trench fills to determine the profile and dimensions of the foundations. The width was confirmed as 50 cm as seen elsewhere, and the depth was only a maximum of 15 cm. The foundations were cut into firm white/cream coloured clay which would make an excellent base for a building. The foundation cuts were very neat and precise. The two stones were found to be not in-situ having probably been disturbed during recycling of the wall material; indeed the mortar occurred in lumps in several places which suggested they had been chipped off wall stones. The small to medium angular stones left in the trenches may have originated from the thin core of the walls.

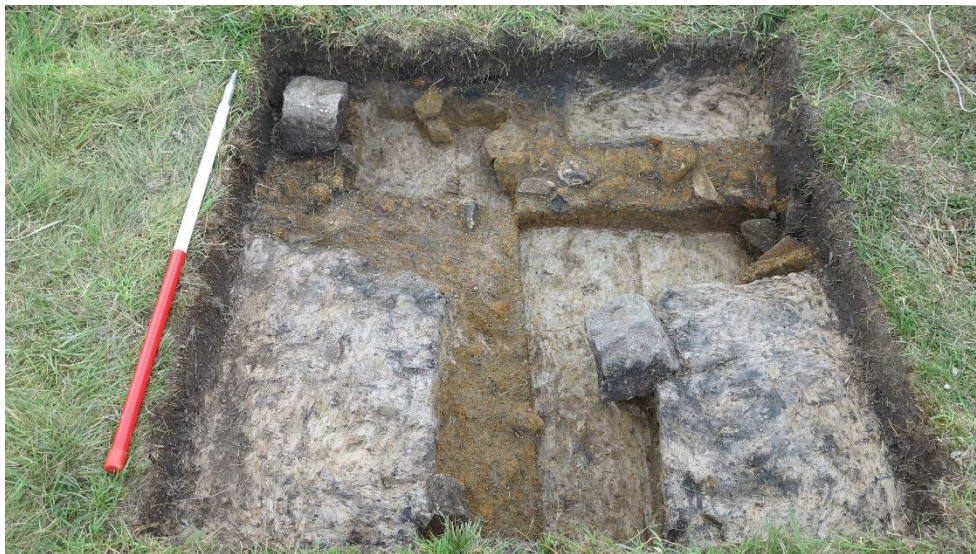
Test pit 1 showing half excavated foundation trenches, looking west.

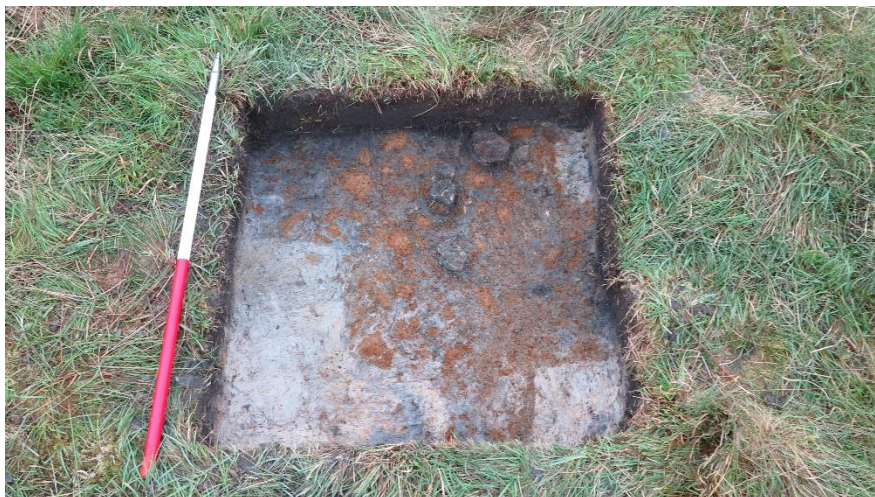
Test pit 17 looking north with the corridor foundation trench visible in the top left corner of the photograph, joining the east wall of the central range, and to the right is the start of a wall for an internal division within the eastern range.

TP17 was only one metre south of TP1 and successfully located the southern wall line for the central corridor where it joins the central range wall. Here only vestiges of the foundation trenches were visible in places.

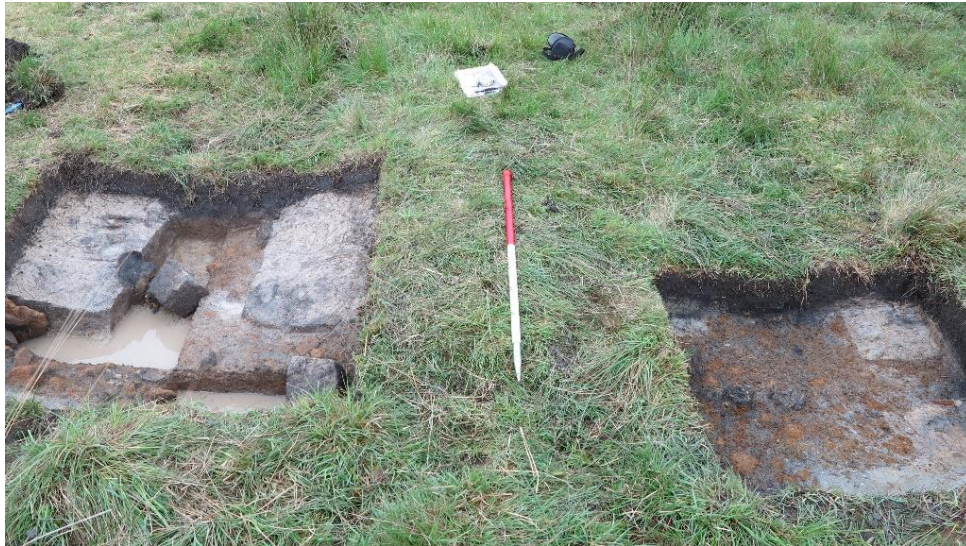
This photograph shows the relationship of TP1 (left) and TP17 (right), looking west.

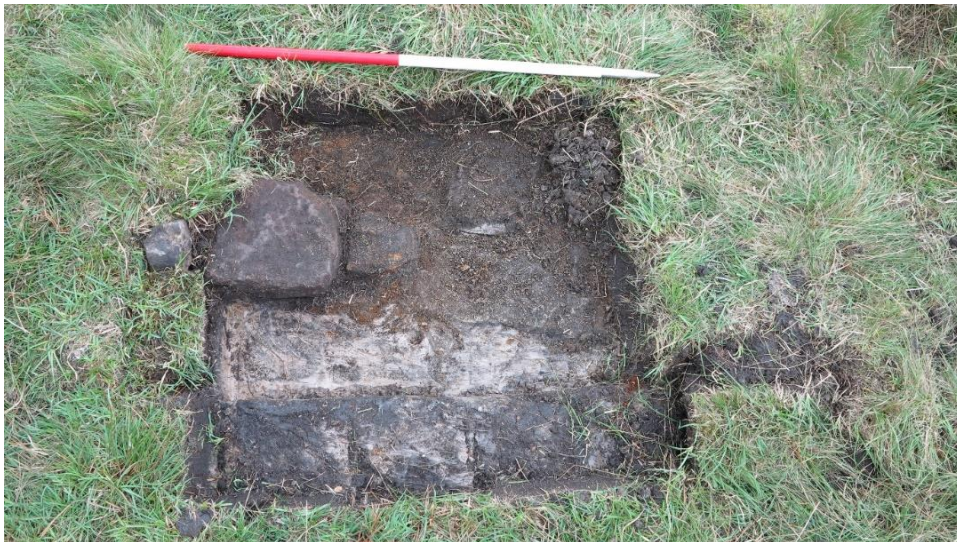
TP16, showing the central range east wall in top half of test pit but with no evidence of intersecting wall for the eastern range.

TP16 was excavated a couple of metres south of TP17 but was unable to locate the junction of the expected southern wall of the eastern range with the central range east wall. A similar situation occurred with TP2 in the western range. A possible interpretation could be that there were matched entrances on either side of the central range, but this aspect of the plan form needs further investigation. What is clear is that a narrow central corridor only 1.5 m wide traverses the central range east to west, linking to rooms in the eastern and western ranges.

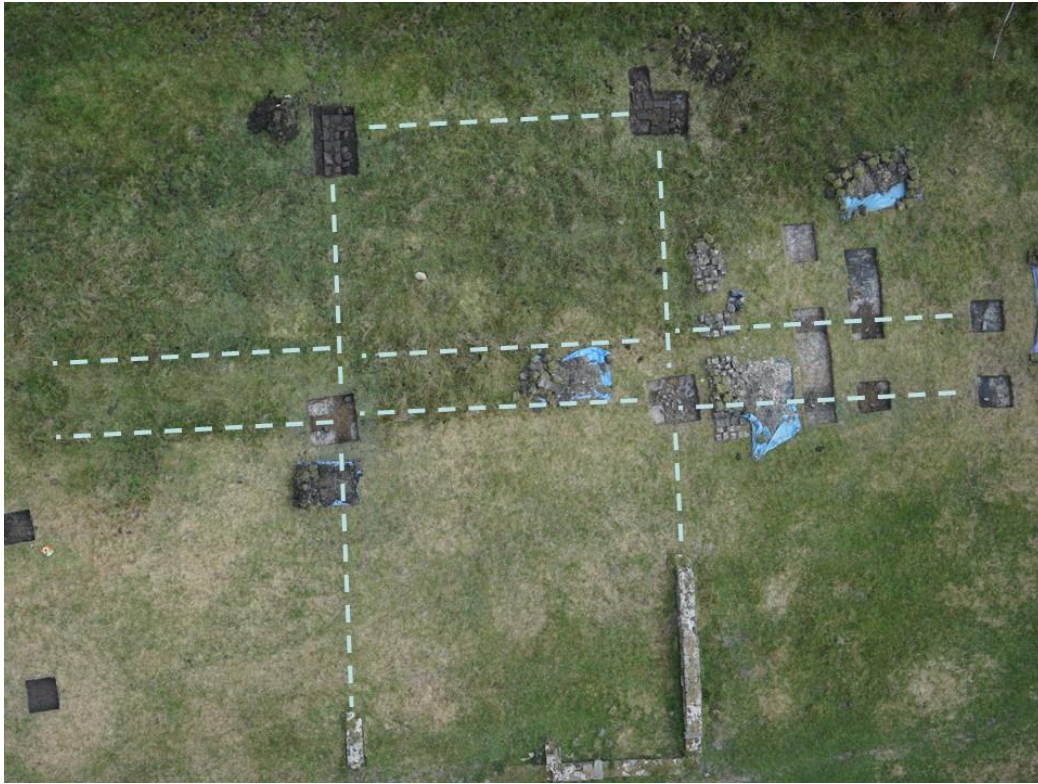
Drone vertical photo of the central range with dashed blue lines showing wall foundations confirmed or suggested by excavation, showing the narrow corridor.

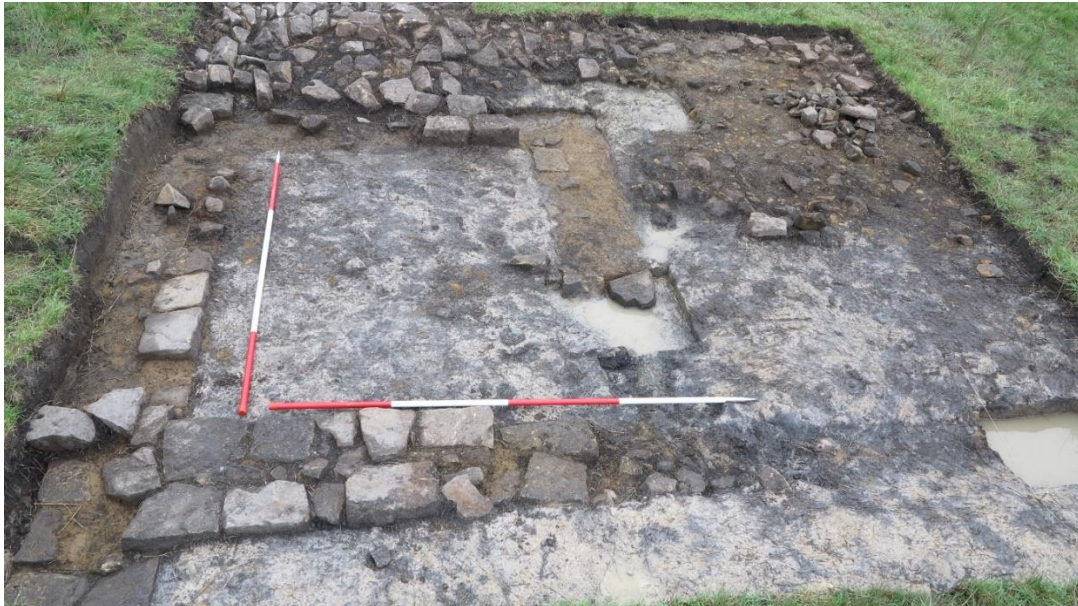
Photo of Trench 1, looking south and showing the projecting small rectangular chamber with photographic scales along the inside of its walls. The end wall of the eastern range is on the left, with the wall base in the foreground being part of the 31.8 metre long south wall of the range. The stone trackway is at the top of the photo.

Exposing a larger area in plan allowed confirmation of the existence of a chamber projecting from the south east corner. It measured 2.4 x 1.7 metres internally and was constructed in the same way as the main building ie. 50 cm wide walls with some foundation stones surviving but with much evidence of wall removal where only the orange mortar was left. There was no evidence for a floor and close-up against the outside of the chamber were remains of a crude stone track. Some of this appeared to spill out into the open area between the chamber and the south wall of the range, as though giving access to the walls during the dismantling process. A slot was excavated across a robbed-out section of foundation wall. The foundation trench was only 10 cm deep and 50 cm wide and neatly cut into the light-yellow natural clay.

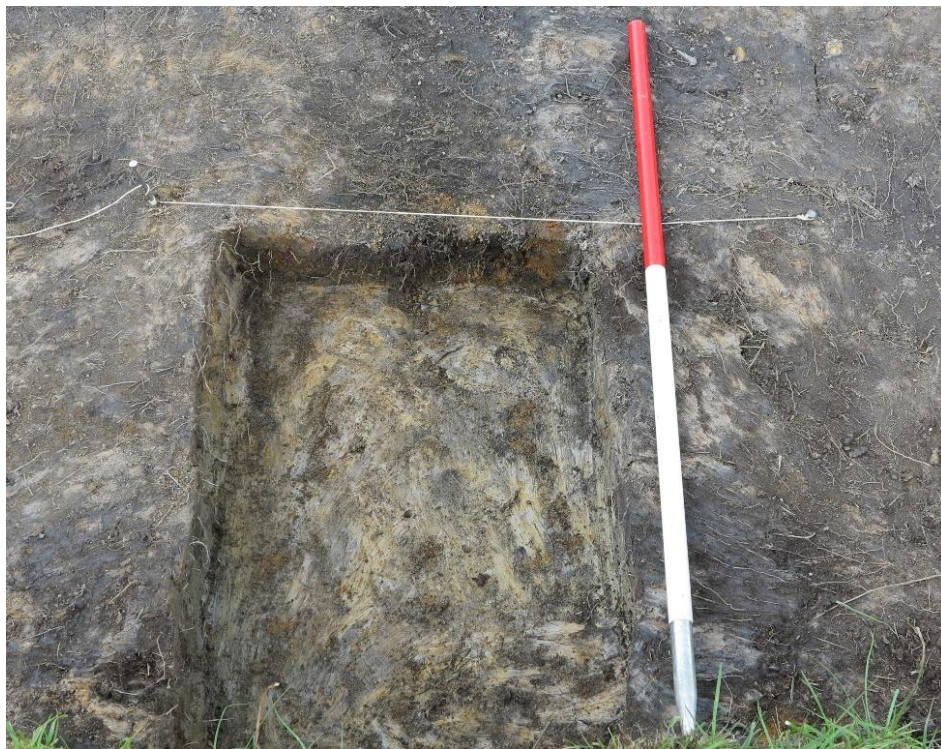
Detail of excavated slot through the foundation trench of the southern wall of the eastern range.

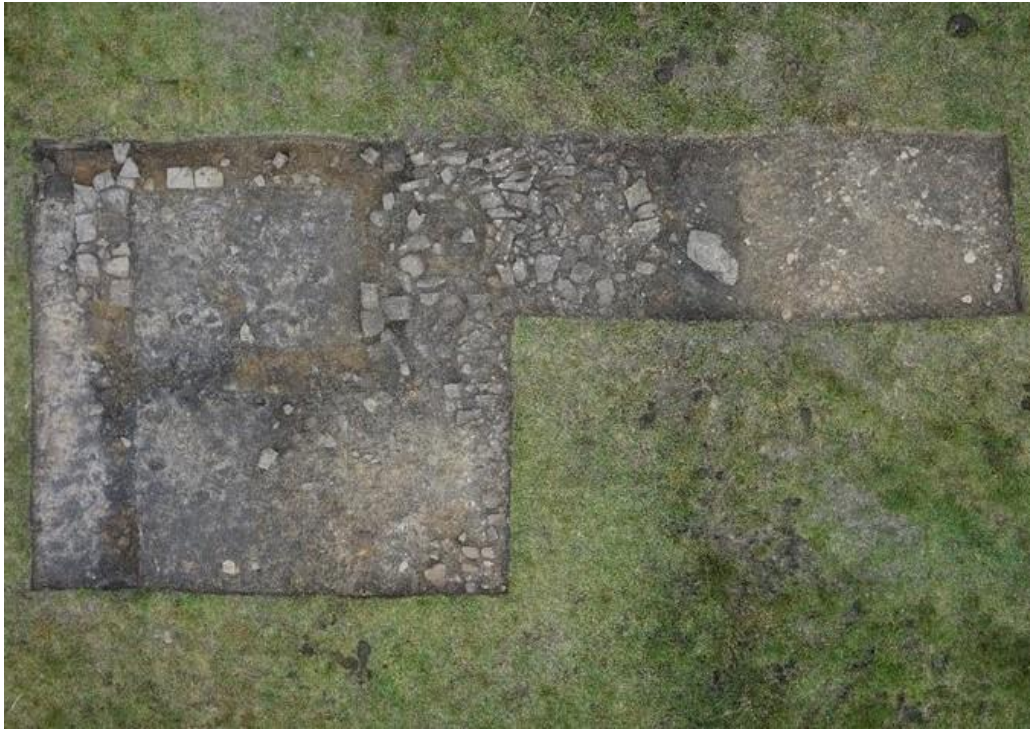
Overhead view of Trench 1 - east is at the top of the photo, with the site of the Roman road on the right side of the trench extension (far right side of photograph).

The 5 x 5 metre square open area excavation exposed only part of the stone track, so a 5 x 2 metre trench was dug from the southern edge. This exposed the full width of the track, an associated drainage gully, and part of the Roman road agger. As seen near the central range, the track comprised angular medium to large gritstones with some crushed and small gritstone pieces forming a bedding deposit. There was no clear evidence of cart ruts here and very little in the way of fine metalling to smooth the surface. The track at this point was 2.8 metres wide with a c 1 metre wide drainage ditch on its south side. On the north side it tightly abutted the wall of the eastern range structure. It was apparent that little survived of the Roman road metalling which could well have been recycled during the construction of the grange building. Only thin spreads of small and occasional medium-sized stones survived in patches, set in mid- grey silty clay and with natural or sub-natural mid-yellow clay beneath. This accorded with results from the test pits across the road line in 2017 and contrasts with the well-preserved remains of the Roman road excavated at Causeway Sett several hundred metres further down the valley towards Delph by Saddleworth Historical Society in the 1970s.

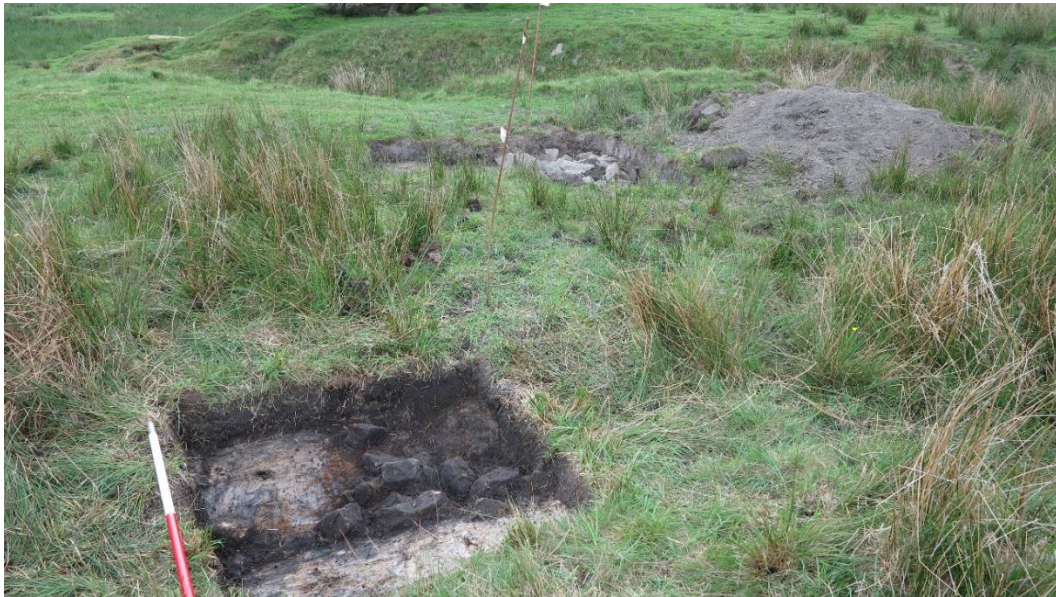
TP 15 revealed the northern wall of the east range as a badly degraded wall foundation cut with filled with orange mortar and angular medium grit stones. At right angles to this, and running northwards, was a return wall for the west side of the small chamber, filled with the same material.

This test pit confirmed the presence of a small chamber projecting from the north east corner of the main building, similar in dimensions to those previously identified at the south east and south west corners. The image below shows TP15 in the foreground with the north east corner of the small chamber visible in the background as a dump of stones lying over the robbed-out foundation trenches (described under site M in 2017 excavation report).

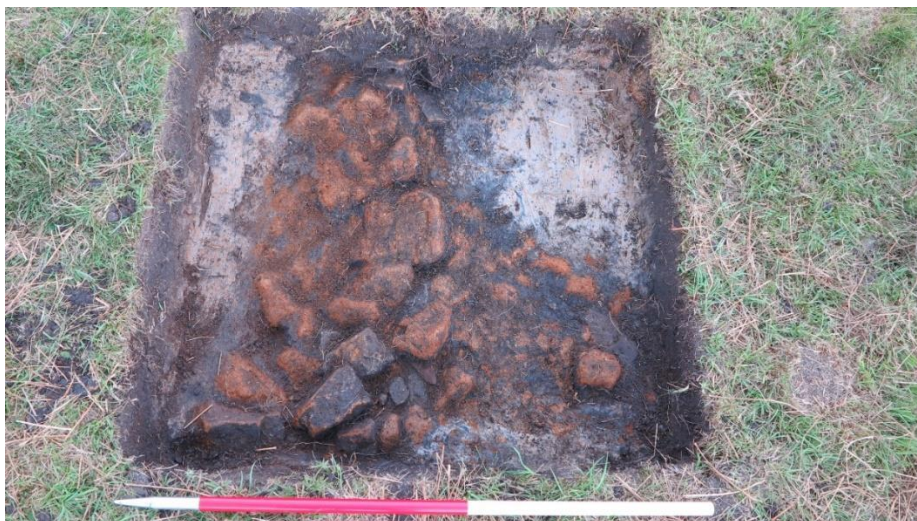
TP8 looking east.

TP8 revealed the site of the main north wall of the eastern range, continuing from TP15. There was evidence for an internal room foundation trench running at right angles southwards from this wall. The foundation trenches revealed in this test pit were jammed with discarded pieces of orange mortar that had been removed from stone walls during the recycling of the building materials. There were also some pieces of angular gritstone.

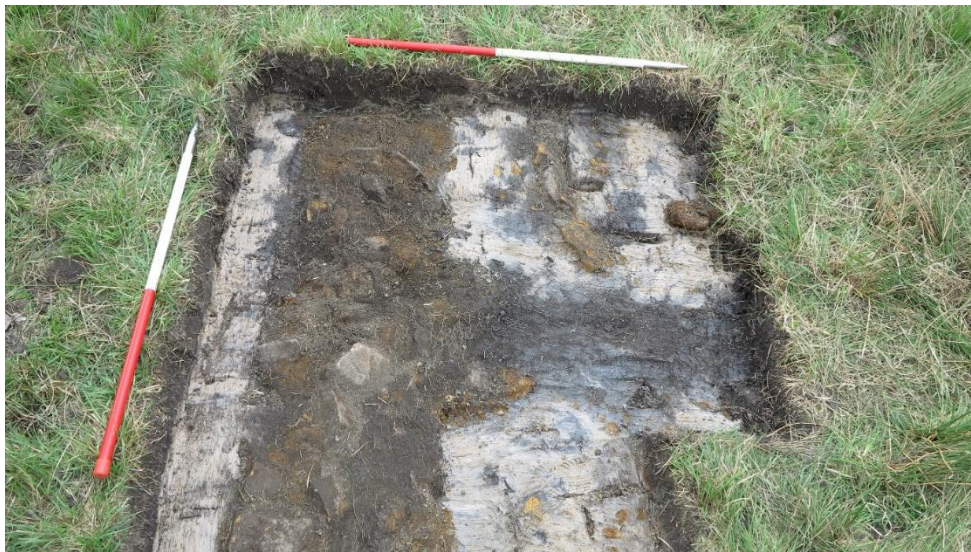
TP11 looking west with return wall foundation trench for an internal room visible on the right.

TP11 located the main southern wall of the eastern range and revealed an internal wall line which partners the one seen in TP 8. The southern wall trench was filled with gritstone rubble and orange mortar, whereas the internal wall was more denuded with just grey silt marking the vestiges of the foundation cut.

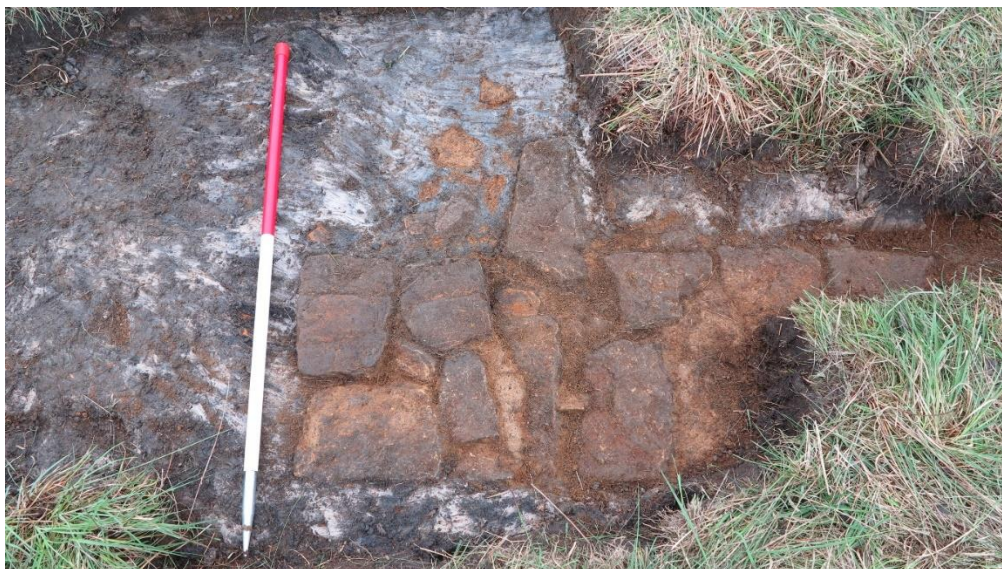
TP19 looking north, showing terminus of the eastern range south wall with offset return wall for an internal room

Following the wall alignment of TP11, TP19 examined the expected junction of the southern wall and another internal return wall closer to the central range. The wall foundation was well preserved with an intact course of gritstones set in the orange mortar and, as elsewhere, was 50 cm wide. But here the wall finished in a straight edge suggesting that a doorway was located here. An iron nail came from the orange mortar. The return wall line was represented by a single long gritstone partly set into the southern wall, but light grey silt and patches of orange mortar marked the base of the foundation trench.

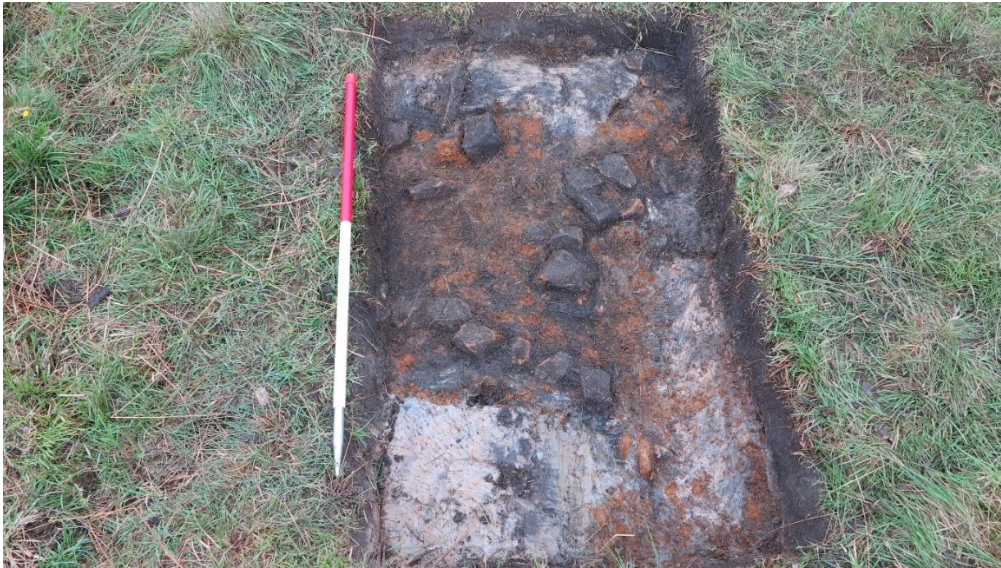
Detailed view of TP18 looking east.

TP18 examined a right-angle cropmark seen in aerial photos which appeared to represent a junction of internal walls. This was indeed the case. A scatter of discarded small to medium gritstones together with plentiful orange mortar and grey silt indicated the foundation trenches. A south to north wall alignment for an internal room intersected with a west to east wall trench so that this test pit revealed a junction of four walls as seen in the image below.

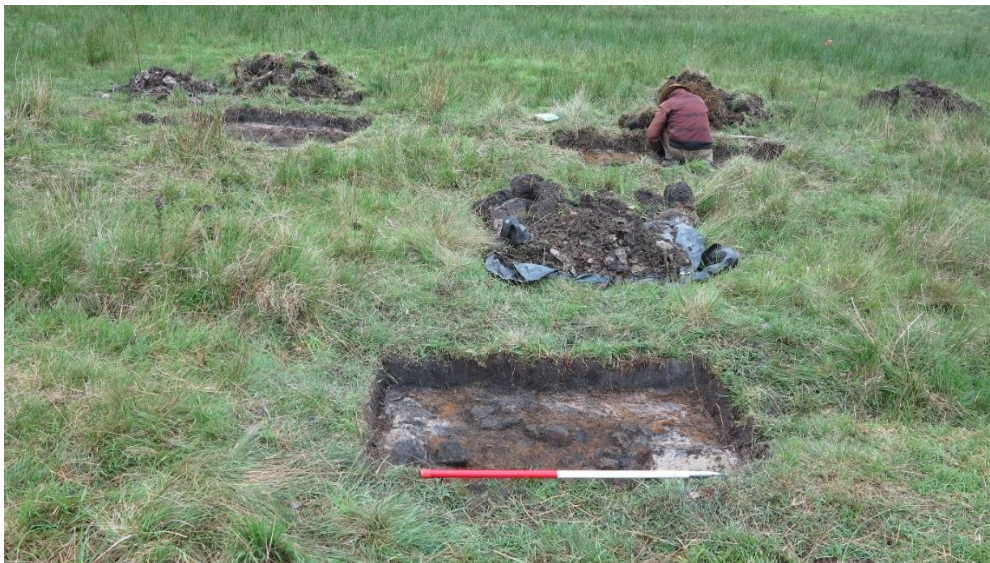
TP18 in foreground looking south towards TP11 (left) and TP19 (right). The excavator is cleaning the southern wall terminus and TP18 has a wall foundation running down to just left of the terminus where a corresponding return was seen in TP19.

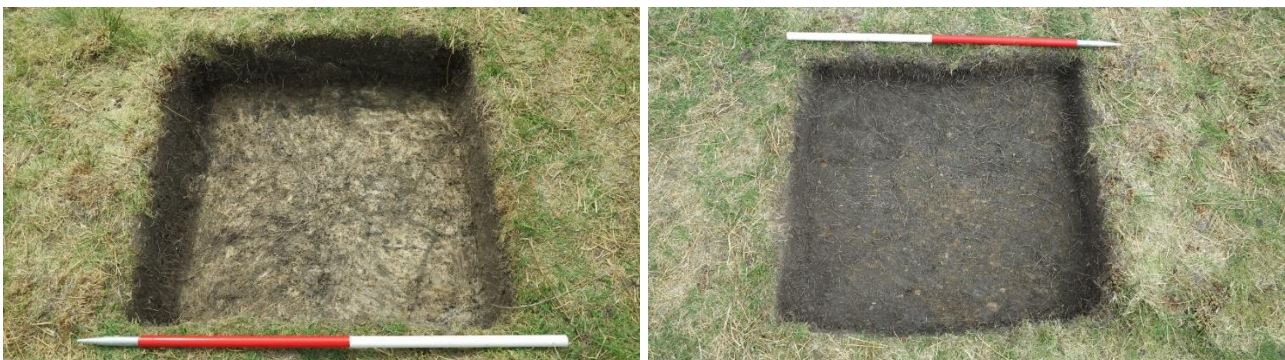
TP7 showing natural clay under thin layer of topsoil and TP10 partly excavated.

These were located north of the eastern wing to test for deposits or features lying outside the building. In TP7 c 15 cm of topsoil was removed to reveal natural white clay. TP10 was not fully excavated as it became apparent that this was the same as TP7.

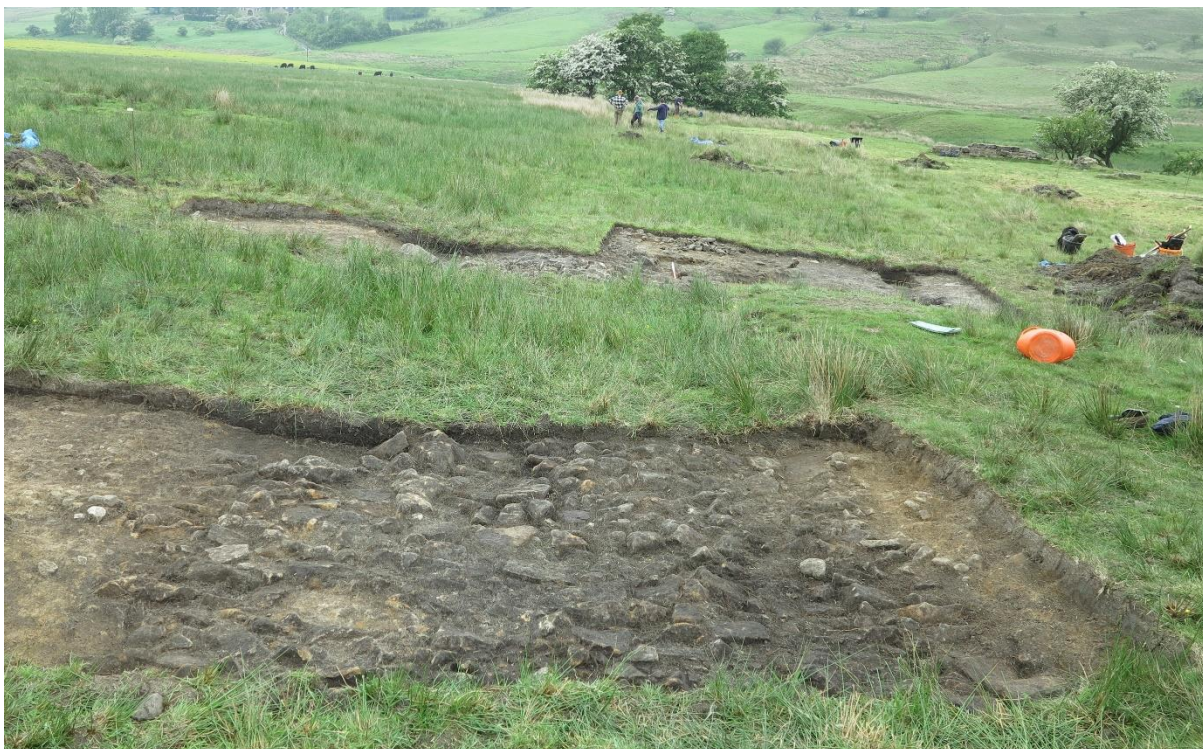
View west across Trench 2 with Trench 1 just beyond, showing the stone trackway

5 metres to the east of Trench 1, another substantial trench (2) was excavated with the aim of following the course of the stone trackway eastwards. This trench was initially 3 x 4 metres then extended southwards by up to 3 x 2 metres, with a further section widened-out in the south-east corner to expose a linear feature. The road comprised similar material to that seen in Trench 1; however, on the north side there was evidence of kerbing with several squared off stones laid in a shallow cut into the clay that had formed part of the Roman road. On the south side the start of the road side ditch was evident as a curved terminus only half a metre into the trench. To the east of this the road widened out to 3 metres across, nearly 1 metre wider than in Trench 1. It is not known why the trackway splays out in this way.
