# Archaeological Excavation of a possible monastic grange building at Water's Clough, Castleshaw, Saddleworth

May 2018

Report written by Norman Redhead  
for the Friends of Castleshaw Roman Forts

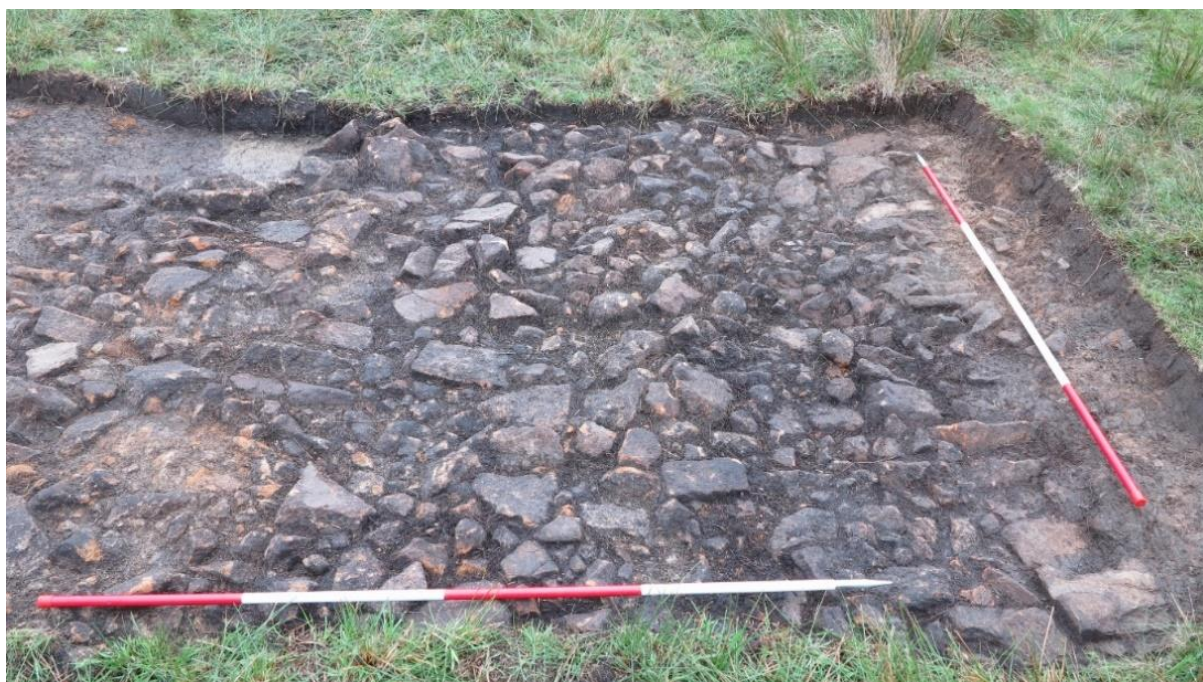
Detail of stone trackway in Trench 2, looking west, with possible kerbing on right (north side) set against the remains of the Roman road on the far right under the scale

It had been anticipated that the track would run up on to the Roman road which would then be utilised for transport; however, the track was found to continue at right angles across the Roman road earthwork and indeed could be seen to be cut into it. This was a surprise and suggests that the Roman road had been so truncated and denuded of metalling that it was not thought worthwhile to re-use it in the medieval period. Where the medieval trackway goes after crossing the Roman road is not clear; this is due to the altered nature of the landscape, with the late 18<sup>th</sup> century Water's mill site and its lodge, as well as a modern trackway, obscuring the terrain.

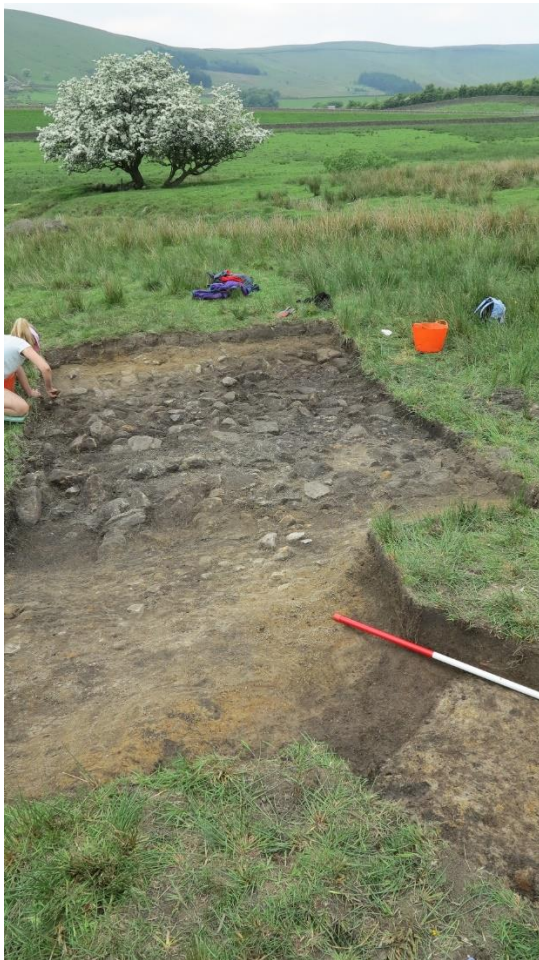
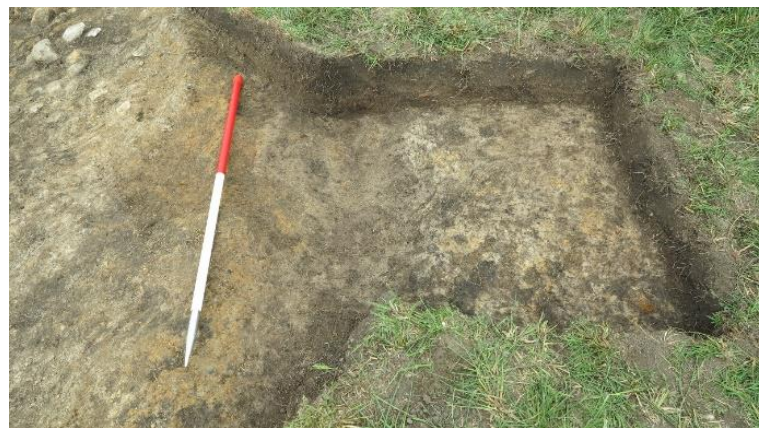
View north across Trench 2 showing the trench extension to expose a linear feature (under photo scale) with the right-hand photo showing the feature post excavation

At the south east corner of the trench a linear feature was exposed that aligned with the former Roman road. It was c 40 cm wide and filled with a dark grey silty clay material. A one metre length was excavated to give a better understanding of its depth and character. It turned out to be quite shallow, only 20 cm deep, with gently sloping sides cut into light orange-yellow clay. There was only the one fill as described above and no finds. It is likely that the clay that this shallow ditch or gully cuts in to forms part of the agger (raised causeway) that the Roman road was laid on to. The ditch is roughly in the right place and on the right alignment to drain the east side of the Roman road; however, it appears to be too shallow and narrow to service a major road. It might represent the very truncated remains of the Roman roadside ditch but could equally be a much later attempt to provide drainage in the last phase of the road or agger's use or even be associated with post-Roman land drainage. An alternative interpretation is that it is a foundation slot for a timber building. Only further excavation would help define its function and date.

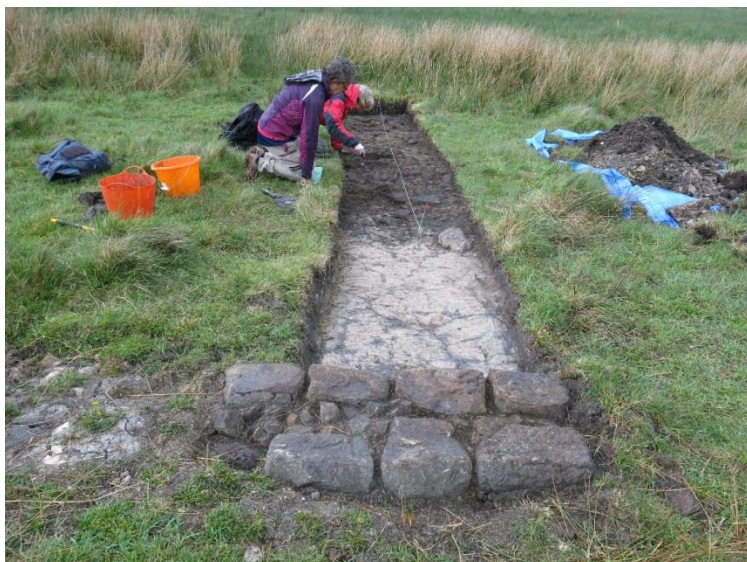
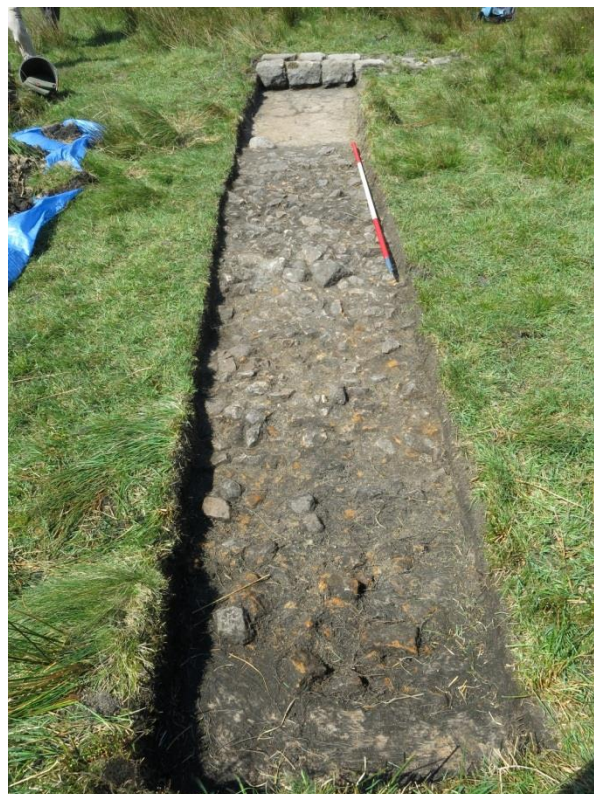
Sue and Margaret excavating a section through the stone trackway (left) and looking north across the trackway (right) with the natural clay visible in the foreground and in the distance between the track and stone foundations of the western range southern wall

This trench was dug at right angles to a well-preserved section of wall foundation roughly half way along the southern side of the western range. The trench was around 1 metre wide and 6 metres long from the exposed outside edge of the wall. It was positioned to reveal the continuation of the stone trackway running alongside the southern wall of the former building, as suggested by the geophysical survey. Sure enough the road was located in Trench 3, although at this point it was 1.6 metres away from the southern wall and separated from that wall by natural yellow-cream clay. This was because it was aiming for the outside wall of the projecting chamber in the south-west corner, mirroring the alignment at the south-eastern corner of the building. The road was 3.8 metres wide and made up of predominantly medium to small angular gritstones, with occasional large ones, giving a smoother surface than seen elsewhere further to the east. It was only one course deep, a maximum of 15 cm and laid on to natural clay.

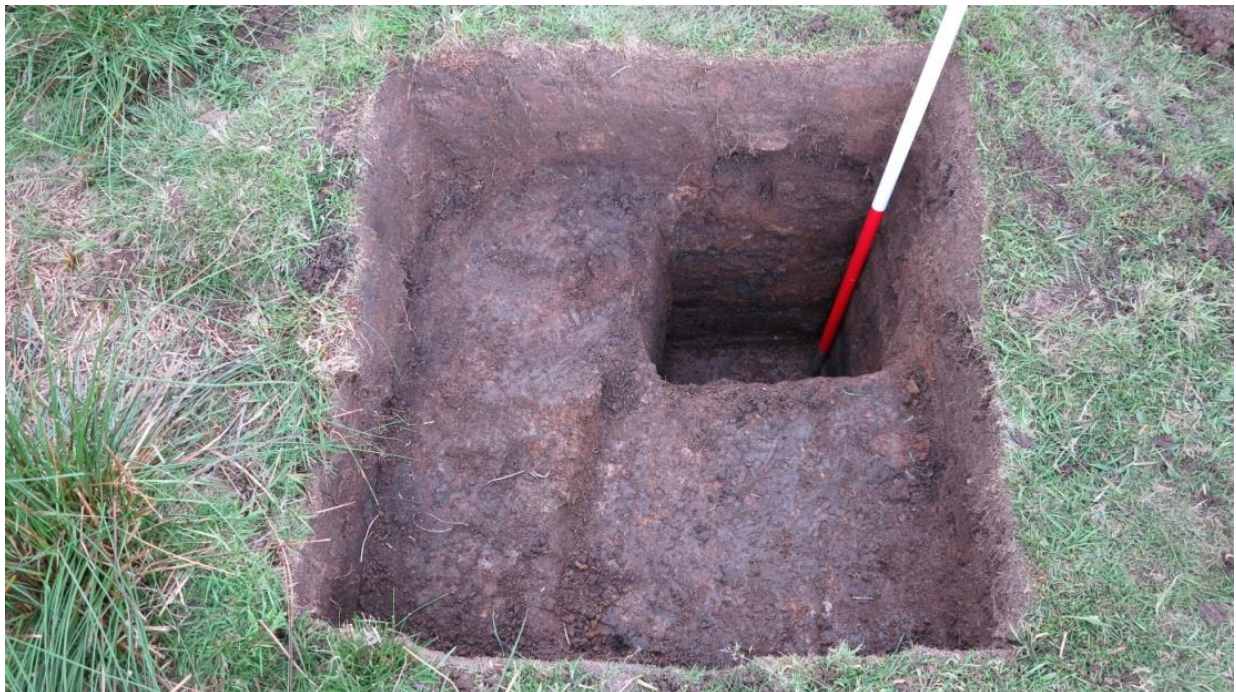
TP 9 with sondage excavated in corner

Test pit 9 was excavated as a 1 metre square test pit located on top of the one of the mounds, located 20 metres south-east of the south west corner of the central range and a similar distance south-west of Trench 2. No structural remains were encountered, instead the test pit revealed a series of humic layers, some of which contained peat. The test pit hit clay at about 1.8 metres depth. Tip lines suggested that this material was redeposited. It is clear that the mounds are made up of upcast and this appears to derive from diagonal drainage trenches cut through water logged, peaty ground. These drainage channels are picked up as anomalies in the geophysics and appear to be of relatively recent (ie. 20<sup>th</sup> century) origin.

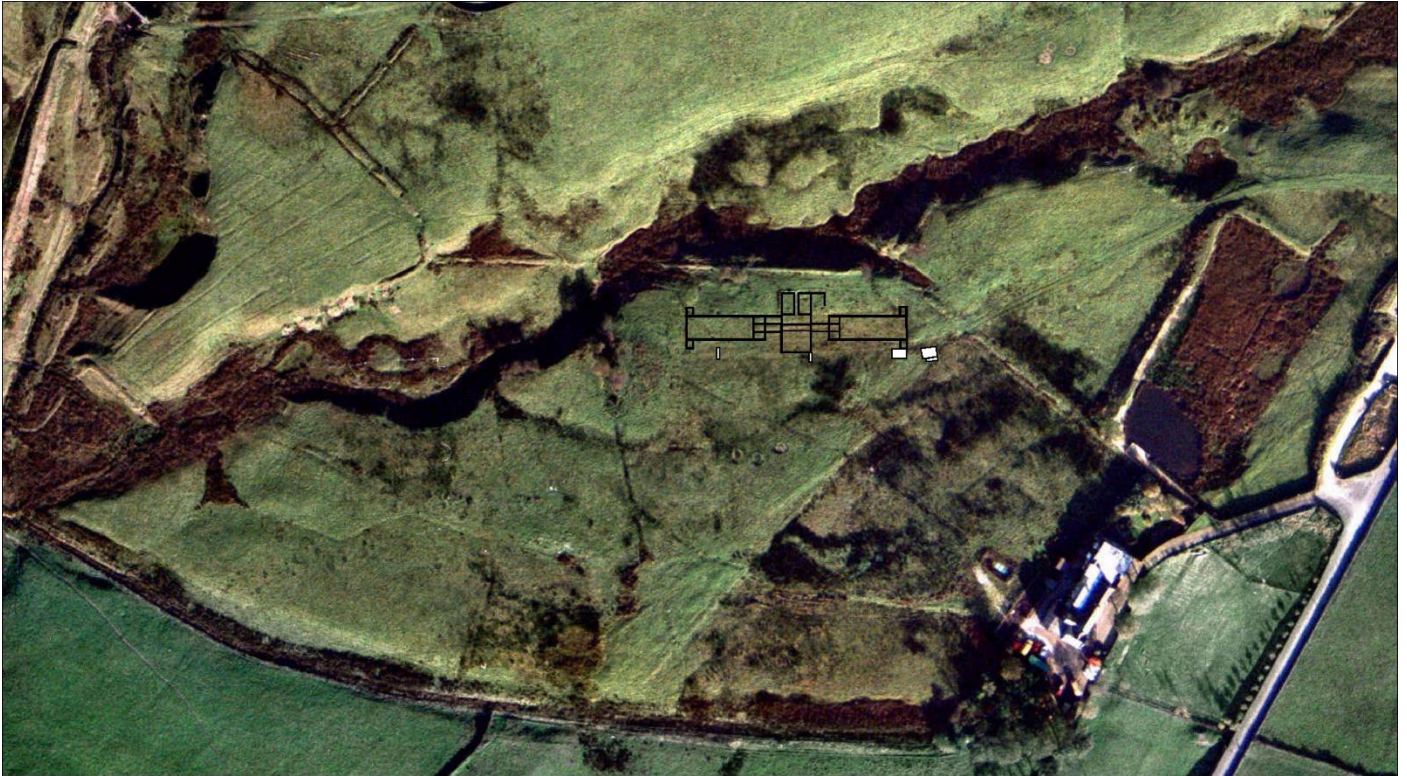
Location of the grange building within its landscape context, with former banked field boundaries showing clearly

walking, shows other similarly constructed field boundaries crossing the valley floor and sides. It is clear that at one time a significant investment in time and resources was made to subdivide the valley into parcels of land for animal grazing.

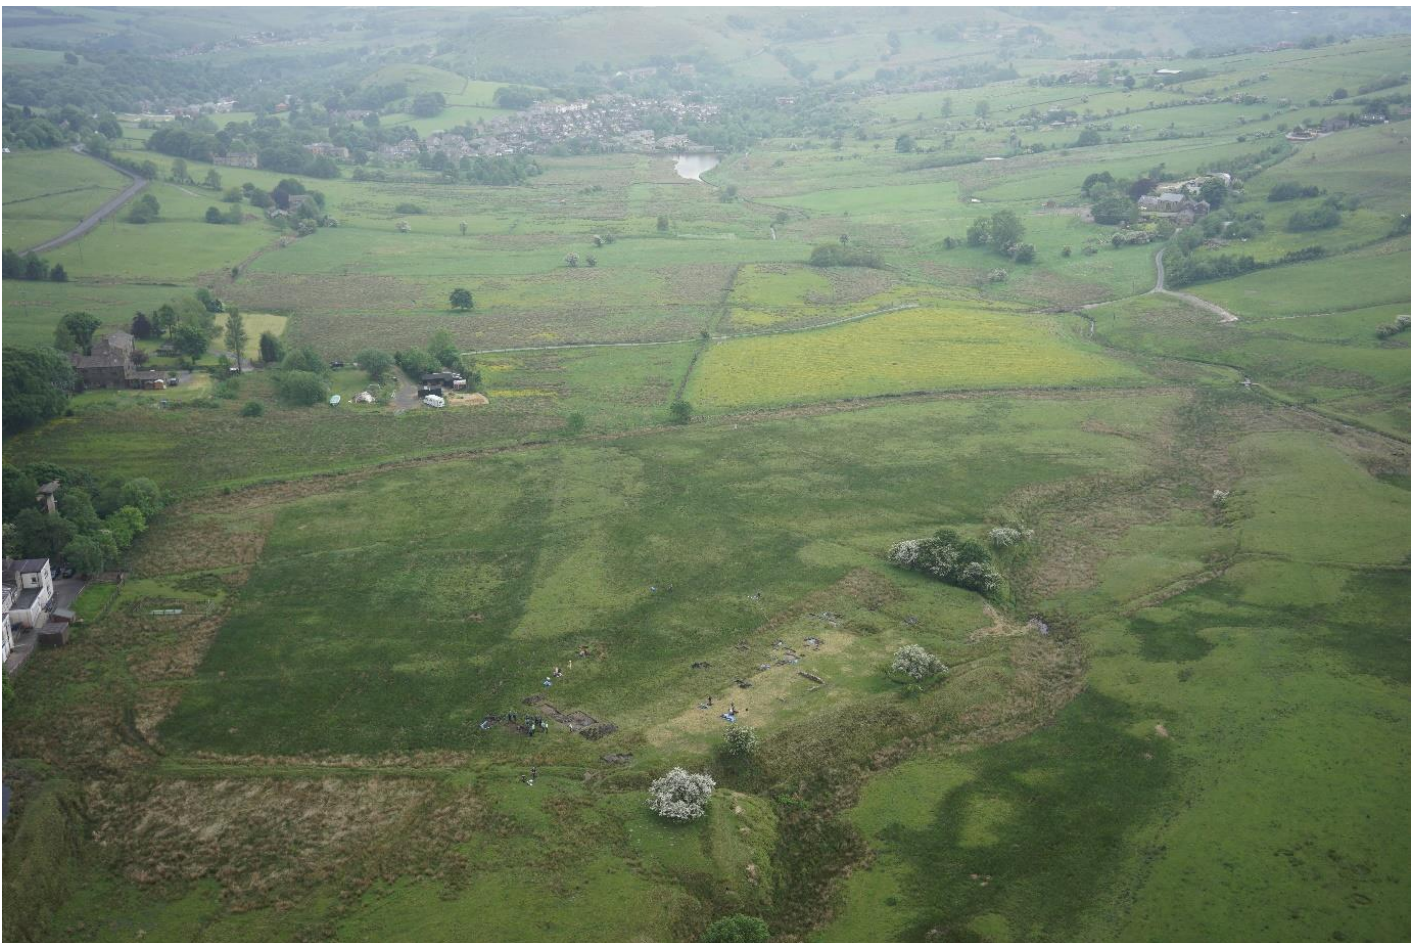
Drone photo from late May 2018 showing the excavation underway on the grange building site in the centre foreground. The hamlet named Grange can be seen at the top right of the photo. The Roman road line can be clearly seen in the middle of the picture as a light green rush-free strip but many other features are also visible, such as former field boundaries, and these now need surveying and understanding in the context of the medieval grange landscape and perhaps earlier features.
